# MUSTANG CONVERTIBLE DIAGNOSIS AND SERVICE PROCEDURES

## DOOR GLASS AND QUARTER WINDOW ADJUSTMENT

# SECTION 47-07 Convertible—Mustang

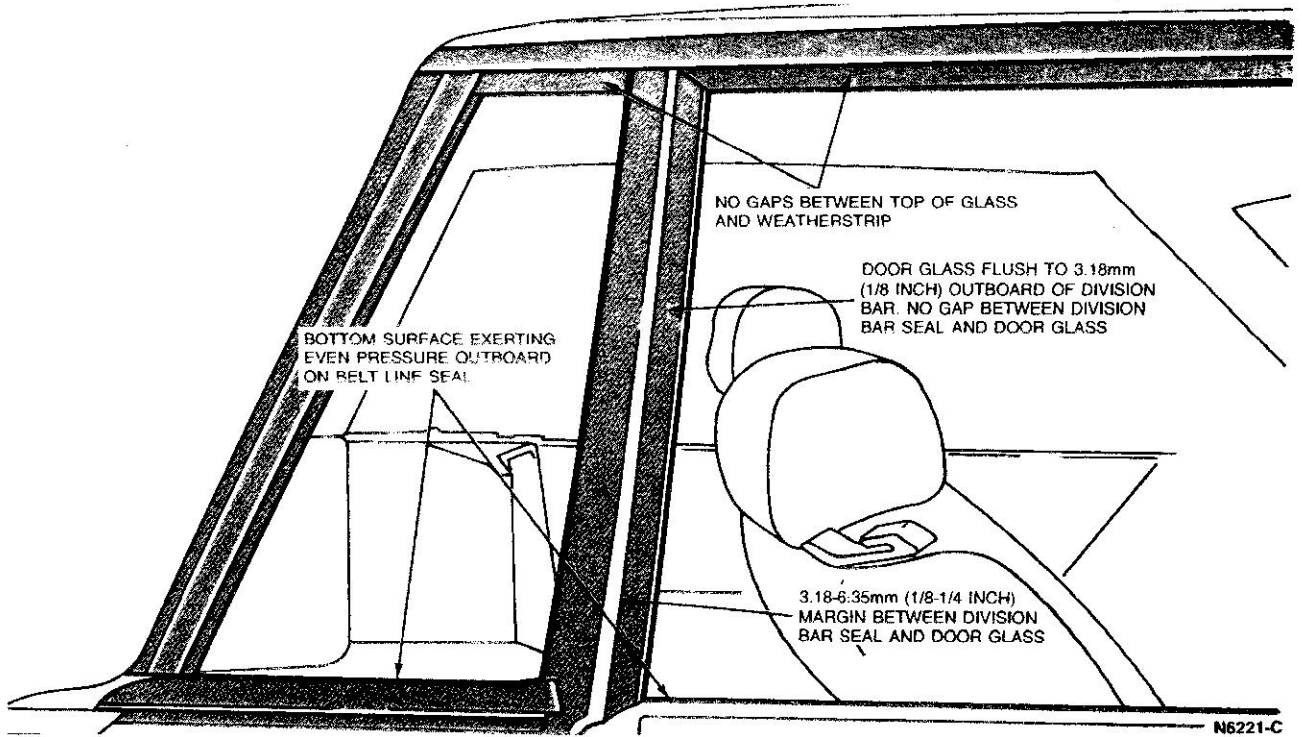
A properly adjusted door glass and quarter window glass should fit as follows:

- There should be no gaps between the top of the glass and the weatherstrip.

- The door glass should be flush to 3.18mm (1/8-inch) outboard of the division bar. There should be no gap between the division bar seal and the door glass.
- There should be an even margin of 3.18-6.35mm (1/8-1/4 inch) between the division bar seal and the door glass.
- The bottom surface at both glasses should exert an even pressure outboard along the belt line seal.
- The quarter window should have an even fit along the entire length of the C-pillar weatherstrip.

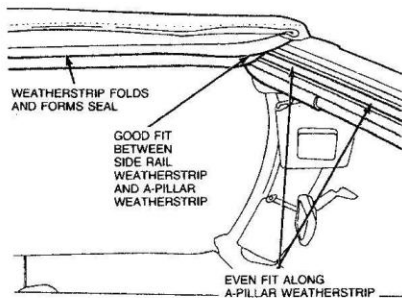
N6223-B

- As the door is closed, the door glass will enter the weatherstrip contour, the weatherstrip will fold to form a seal and the glass will stop.

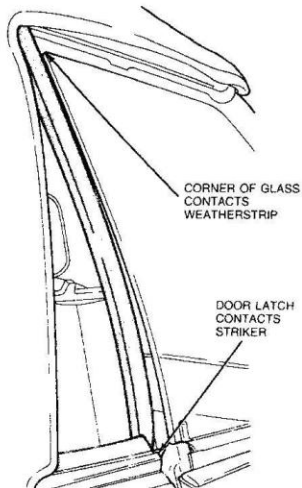
N6224-B

- The corner of the glass will make contact with the weatherstrip just as the door latch mechanism contacts the door striker. With the door glass in the full up position, slowly close the door. When the corner of the glass touches the weatherstrip, a faint "click" will be heard as the door latch contacts the door striker.

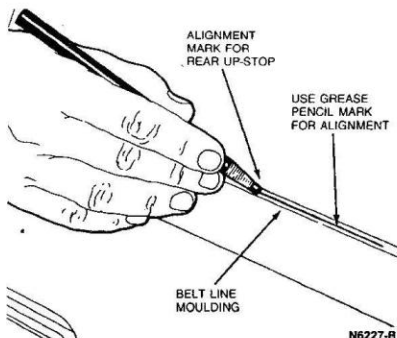
N6227-B

- Using a grease pencil, scribe an alignment mark on the glass along the belt line moulding. Scribe a vertical line above each up-stop adjustment point. This provides a reference point for adjustments. Remove door trim panel.

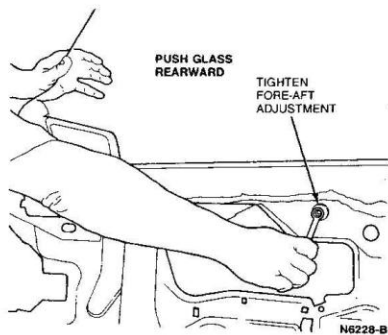
- If necessary, loosen all adjustments.
- Push the door glass to its full rearward position and tighten the fore-and-aft adjustment.

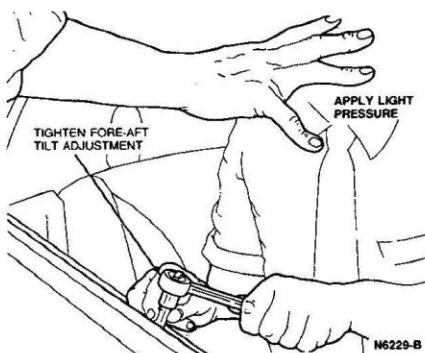
- Have an assistant sit in the front seat with the necessary tools to tighten the adjustments and close the door.
- Position the glass in the door opening and hold it in place as close as possible to the correct position in relation to the weatherstrips and quarter window. Apply a slight pressure at the top of the glass while an assistant tightens the fore-and-aft tilt adjustment.

NOTE: The adjustment is accessible through the opening between the door glass and inner door panel.

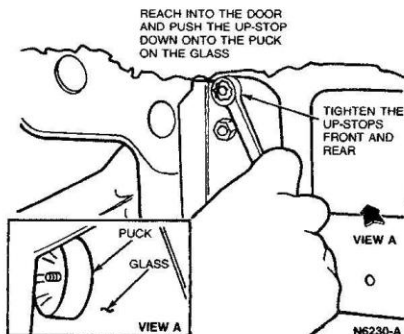
- Hold the glass and have an assistant tighten the front and rear up-stops. Push the up-stops downward against the plastic puck on the door glass and tighten the adjustment.

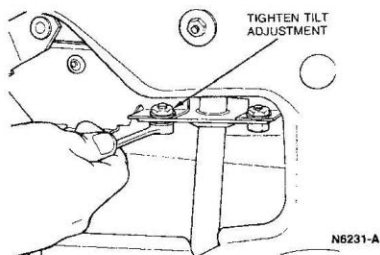
- While holding the door glass in position, lower it approximately 152.4mm (6-inches) and tighten the in and out tilt adjustment.

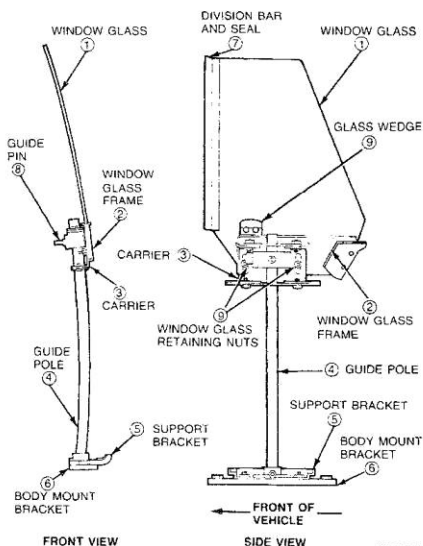
The quarter window glass is nested in a metal frame which is attached to the window carrier. The window carrier is guided by a curved pole pinned to a support bracket which is attached to the vehicle body through another mounting bracket. The quarter glass to door glass seal is an integral part of the division bar attached to the lead edge of the quarter glass. Window movement is accomplished through the window regulator assembly attachment to the carrier guide pin.

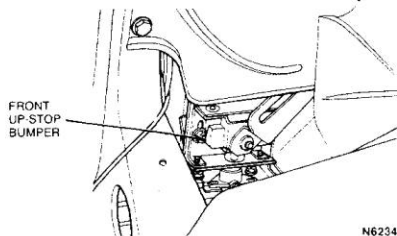
1. Lower window until carrier is exposed below the regulator panel.
2. Remove front up-stop. Inspect for deformation. If deformed, replace and check window alignment.

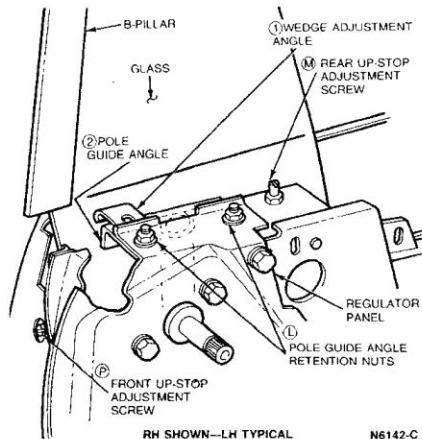
1. Loosen the pole guide angle retention nuts and position the pole guide angle outboard at the front edge only enough to eliminate the gap.

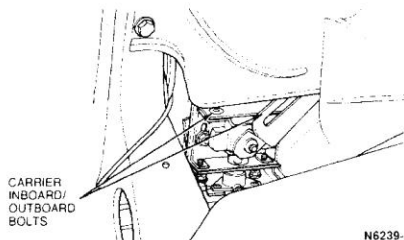
5. If the gap is still evident, lower the quarter window and loosen the carrier in/outboard bolts. Raise the quarter window and position the division bar seal tight to the door glass. Lower quarter window and tighten the carrier in/outboard bolts. Raise the quarter window and check the seal.

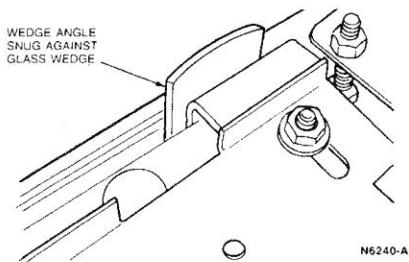
1. Perform preliminary adjustment.
2. Lower the quarter window and loosen the carrier in/outboard bolts. Raise the quarter window and position the division bar seal snug to the door glass. Lower the quarter window and retighten the carrier in/outboard bolts. Raise the quarter window and check the seal. Repeat procedure if necessary.
3. Verify that the wedge adjustment angle is snug up against the glass wedge.

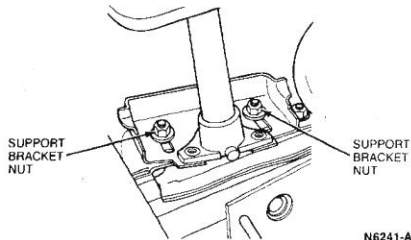
1. Perform preliminary adjustment.
2. Verify that the wedge adjustment angle is snug up against the glass wedge. If not, loosen the rear pole guide angle retention nut and move the wedge adjustment angle outboard snug against the quarter glass wedge.
3. Cycle the quarter window and door glass a number of times to check for crossover. If the condition still exists, proceed to the next step.
4. Loosen the support bracket mounting bolts and slide the support bracket outboard while maintaining a good seal at the division bar. Cycle the quarter window and door glass checking for crossover. If condition still exists, slide the support bracket outboard more until the crossover ceases. If this adjustment will not completely eliminate crossover, continue to the next step.

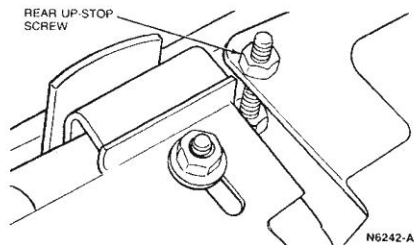
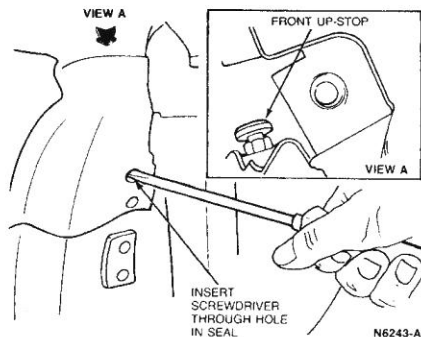
1. Perform preliminary adjustment.
2. If condition still exists, adjust the rear up-stop adjustment screw clockwise until the quarter glass and door glass are parallel. If the gap between the quarter glass and door glass is too narrow, adjust the front up-stop adjustment screw clockwise until the desired spacing is obtained. Cycle the quarter window checking for repeatability. If the quarter glass is lower than the top edge of the door glass, proceed to Step 3. If OK, proceed to Step 4.

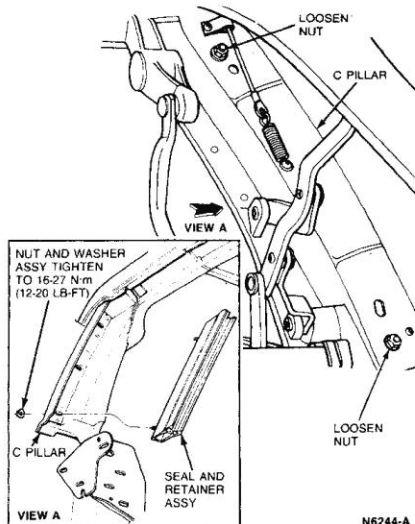
1. Cycle front and quarter windows alternately to check repeatability of alignment adjustments.
2. Lower quarter window.
3. Raise and latch top.
4. Loosen C-pillar seal retainer. (Retainer base must be moveable).

5. Raise quarter glass to full-up position.
6. Set and tighten C-pillar seal retainer. Tighten to 16-27 N·m (12-20 lb-ft).
7. Cycle top and door/quarter windows to verify repeatability of alignment adjustments.

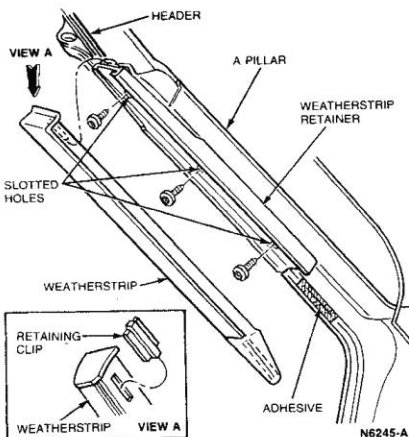
1. If the A-pillar weatherstrip is not centered on the door glass with the door closed and the glass in the full up position, the weatherstrip retainer must be adjusted inboard/outboard.
2. Disengage the weatherstrip retaining clip from the retainer by pulling upward. Disengage the weatherstrip from the retainer to gain access to the mounting screws. Loosen the screws, install the weatherstrip, and close the door. Cycle the door glass a few times to center the retainer.
